Guided Wave Inspection of Rail Level Crossings

Case Study 17

Rail Level Crossings

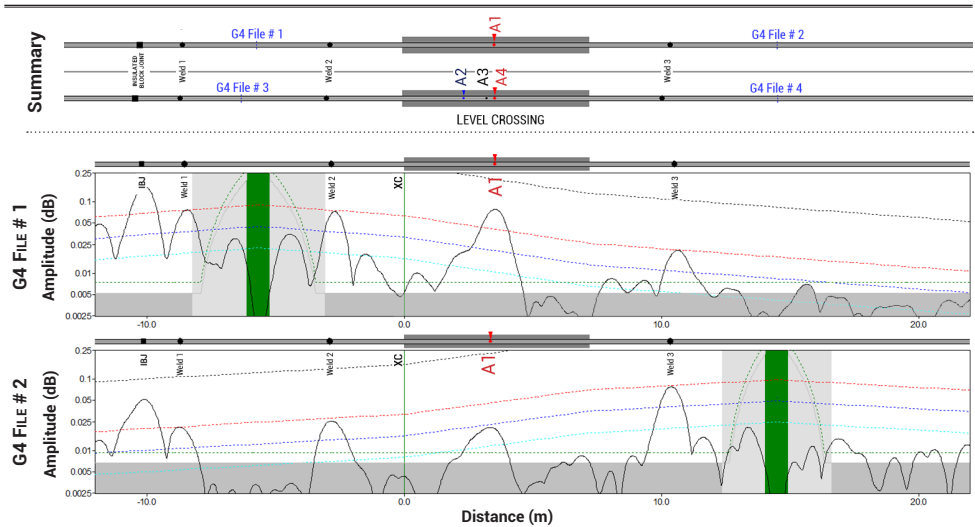
WavePro™ - GWT Results

A summary of the tests carried out on both rails of a level crossing is shown above. The locations of the detected defects are marked, indicating their severity by their colour (red - Severe, blue - Medium and black - Minor). Test results from one of the rails are shown below the summary, displaying the detection of a severe indication close to the middle of the crossing.

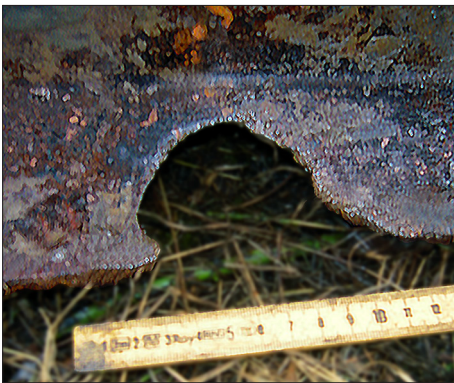
Once the roadway was removed the defects shown below confirmed the findings given by the G-Scan inspections.

Defect found at location of GWT Indication A1.

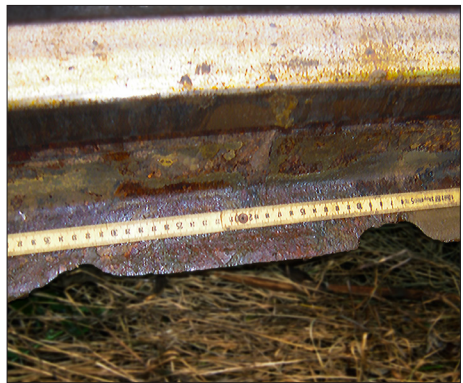
Defects found at locations of GWT Indications A3 & A4.
