Guided Wave Inspection of Caissons

Case Study 18

Using Guided Wave Testing to monitor Caisson integrity

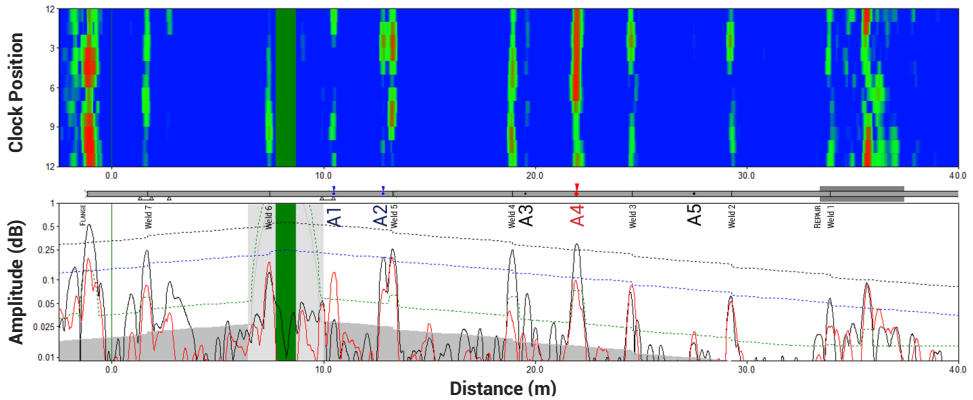
WavePro™ - GWT Results

The Wavemaker® result from one of the inspected caissons is shown above. Several indications of metal loss were detected. The most severe - located just below the water line and labelled A4 - was estimated to be a 27% loss of pipe cross-section with around 50% wall loss.

Other indications showed similar accuracy with defects being detected down to 3% CSA.

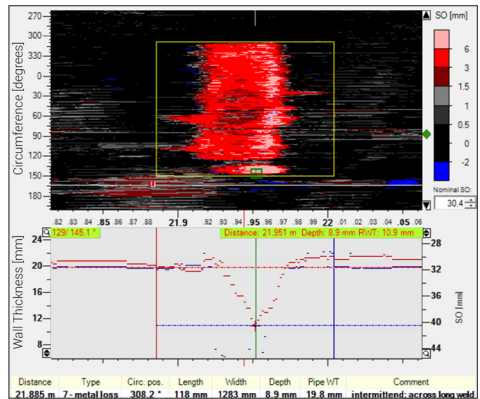
The UT result at the location of A4 is shown in the image to the right. A measured total cross-section loss of 25% and wall loss of 45% at this location confirmed the Wavemaker® findings.

UT Result at the location of GWT Indication A4. Defect found at 21.88m from reference point, with 45% wall loss.
