# Case Study 14: Internal Corrosion

## Job Details

- 6" crude oil line
- Non-painted surface
- Desert terrain with no pipe supports
- Partially buried in sand

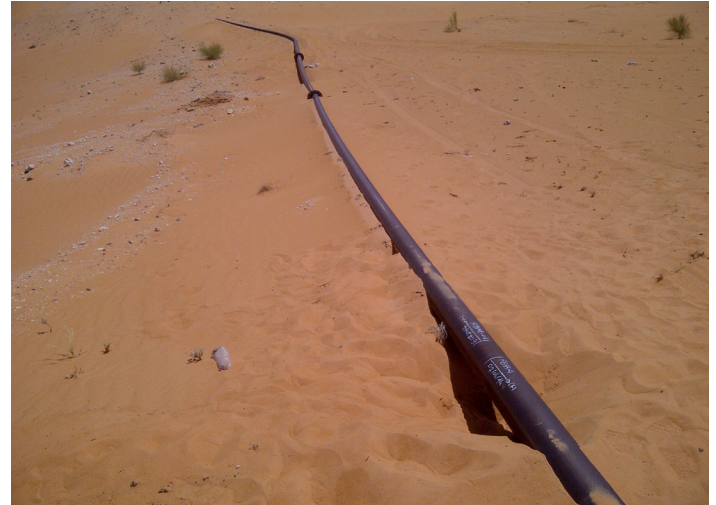
An overview of 6" flow line.

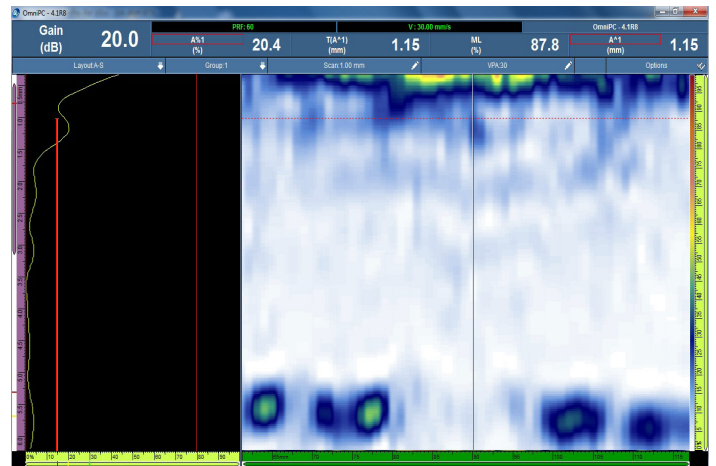
- Over 20m of pipe was inspected from a single location
- Several locations of internal corrosion were positively identified.
- B-Scan prove up confirms the defect severity

B-Scan prove up at the severe defect location which confirms the internal corrosion.
